The Effect of Sediment Pollution from Hangman Creek on the Spokane River

A citizen science partnership between Spokane Falls Trout Unlimited and the
Spokane Riverkeeper

September 4th, 2018

Presented to Spokane Falls Trout Unlimited Monthly Meeting

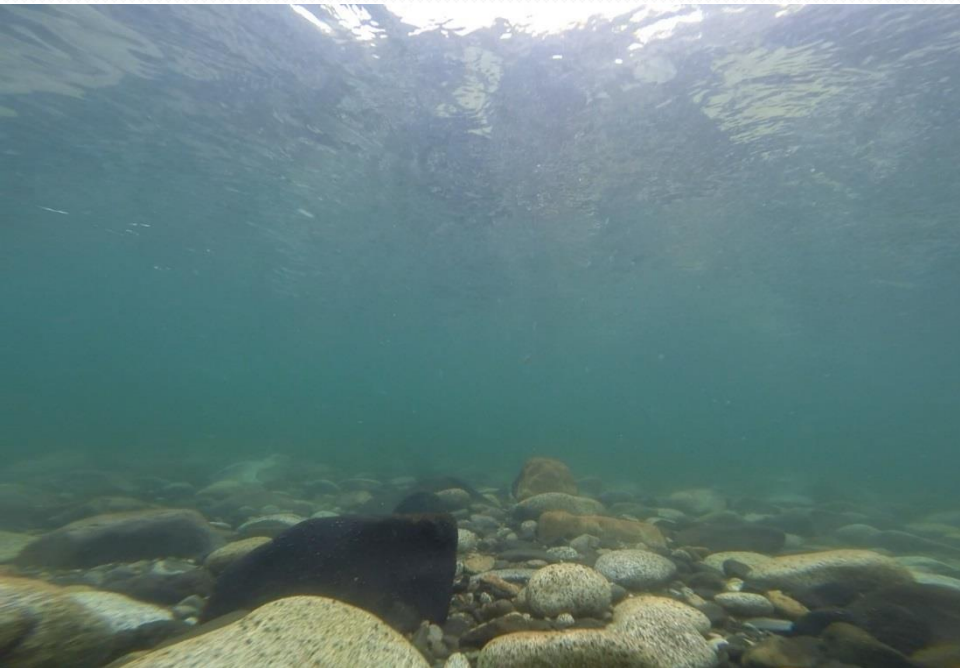
Effect of Sedimentation in the Spokane River

Before

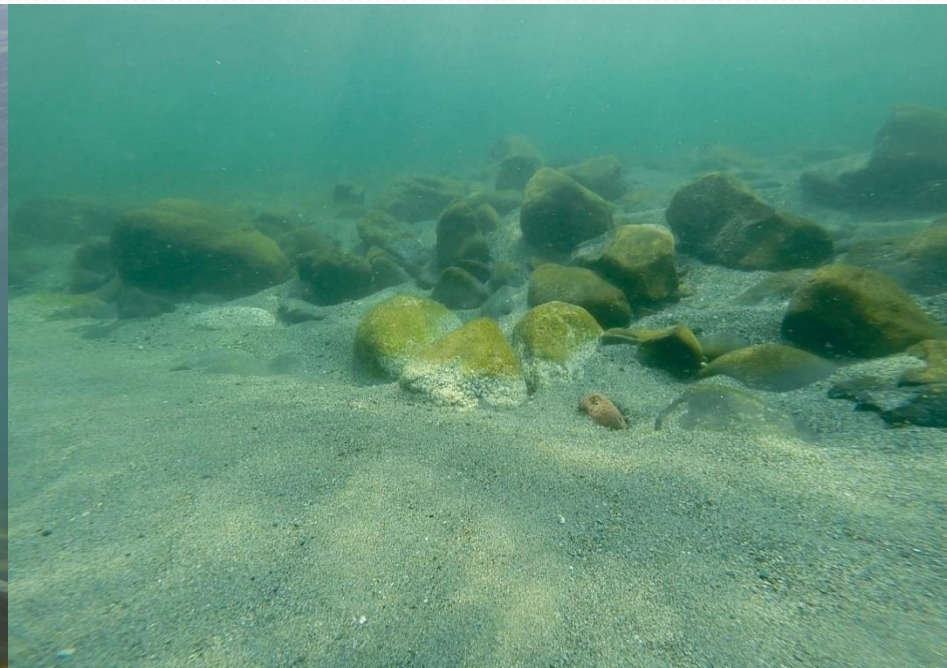
After

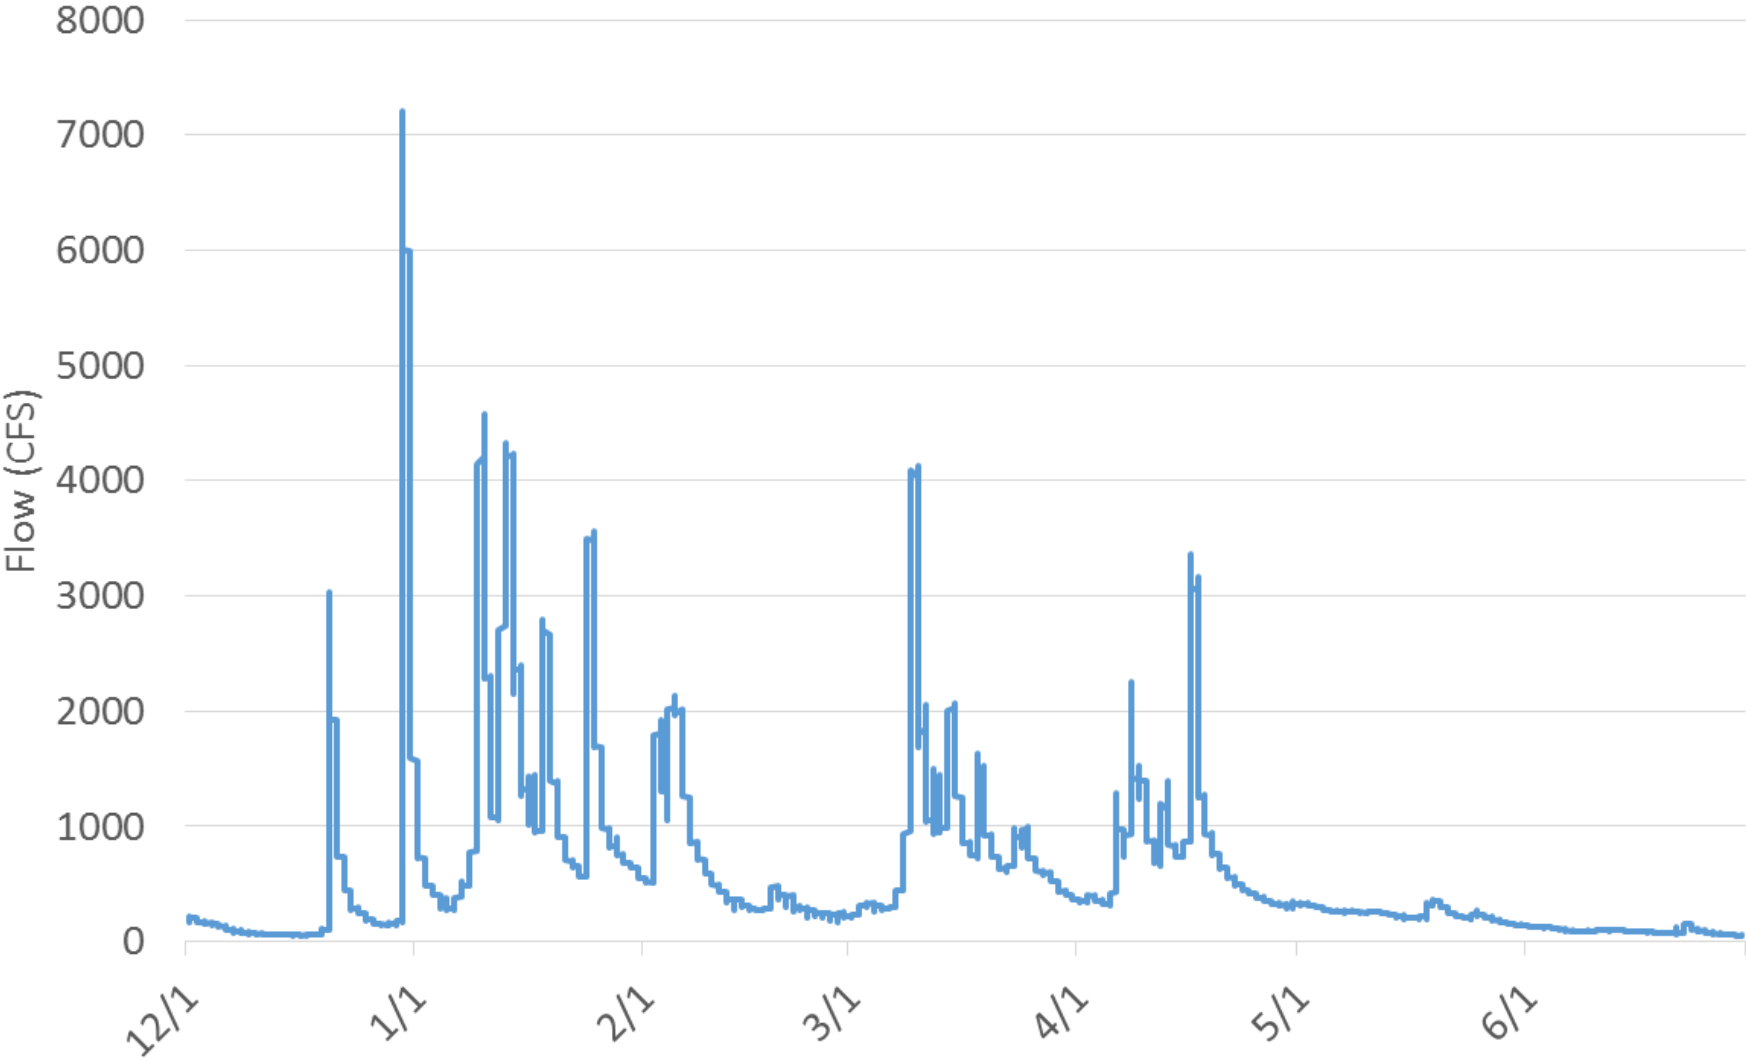
Hangman Creek Flow 2018

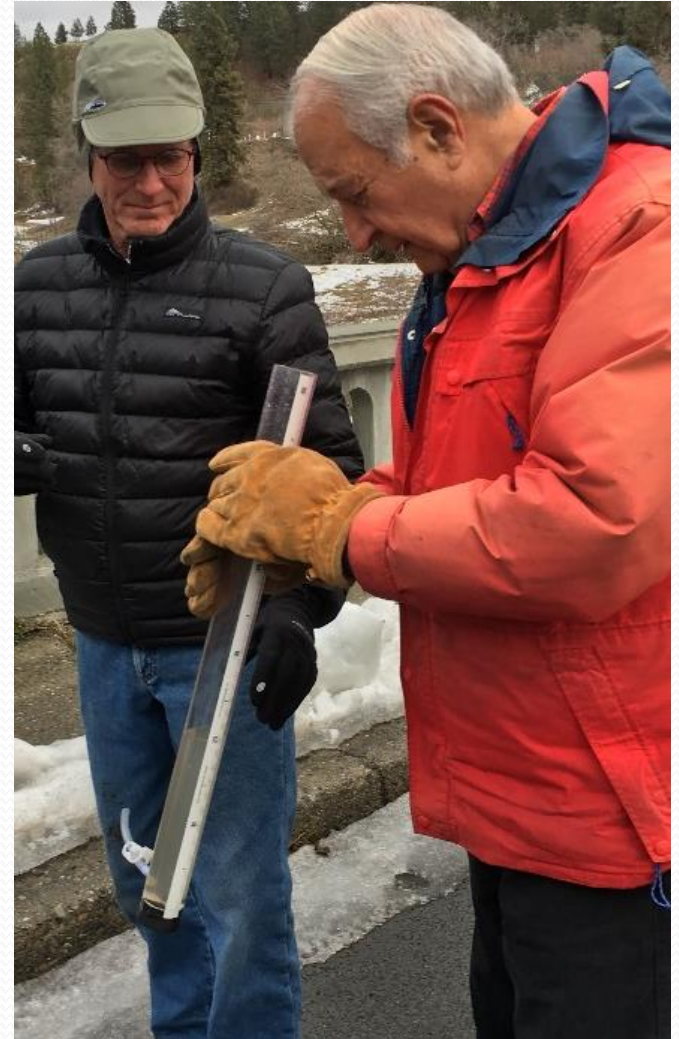
- Easily measured!
 - Transparency Tube to measure transparency
 - Analogous to ***Turbidity***
 - Results in centimeters
- Method – measure transparency in
 - Hangman Creek
 - Spokane River above and below the Hangman Creek Confluence

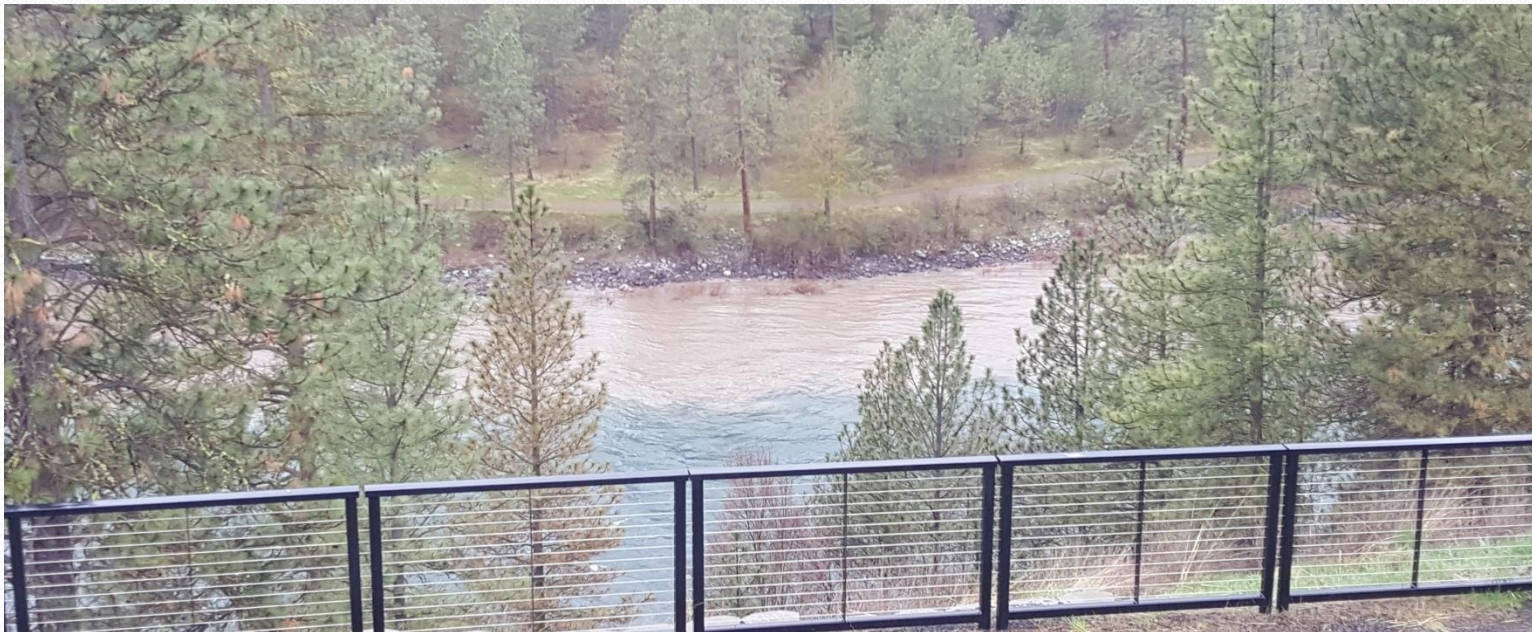
Transparency Data Summary

Location	N	Median (cm)	Min (cm)	Max (cm)
11th Street - Hangman	69	21.3	3	60
Riverside Cemetery - Spokane	57	26.8	2.5	60
Sandifur Bridge - Spokane	49	60	37	65
TJ Meenach Bridge - Spokane	63	60	6	65

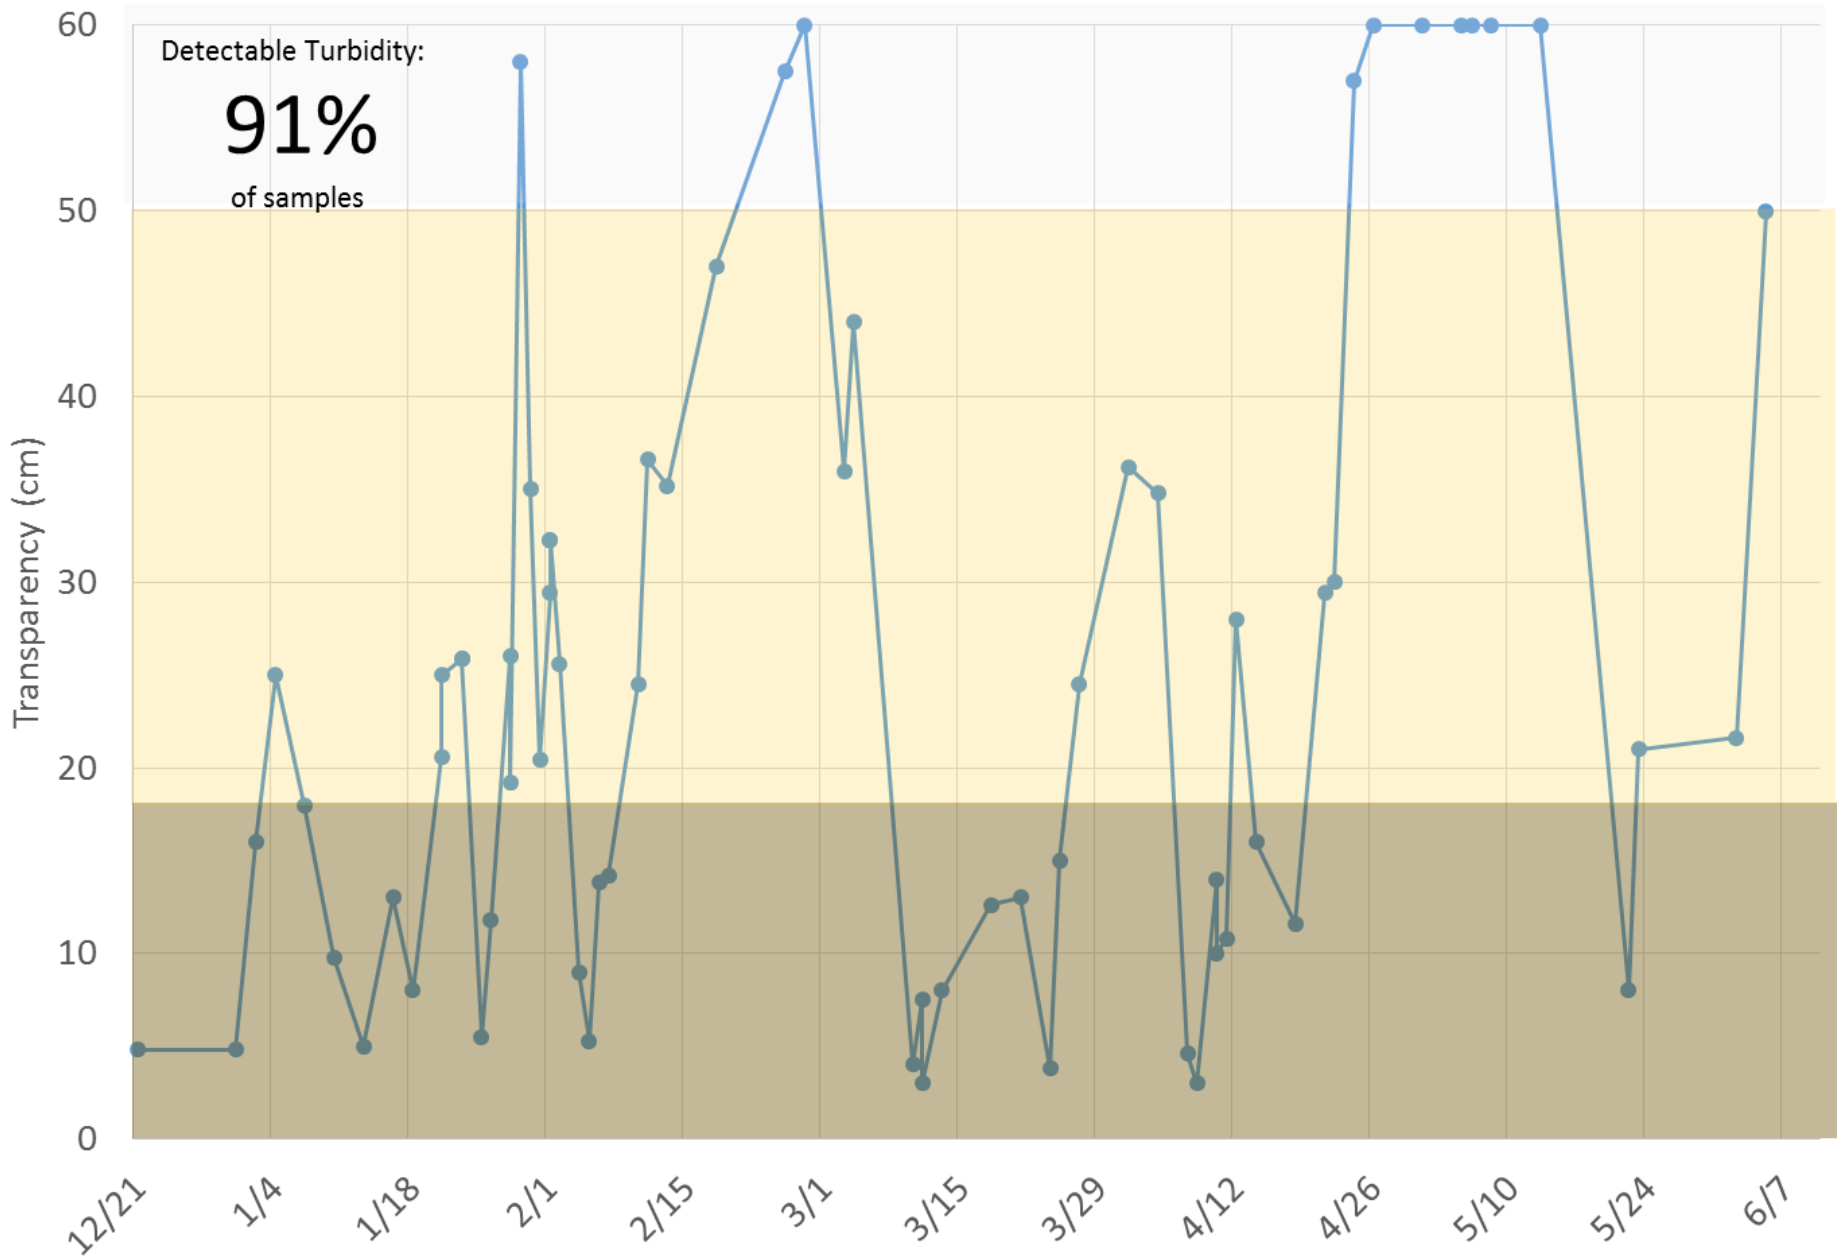
Hangman Creek-11th Street Bridge Transparency

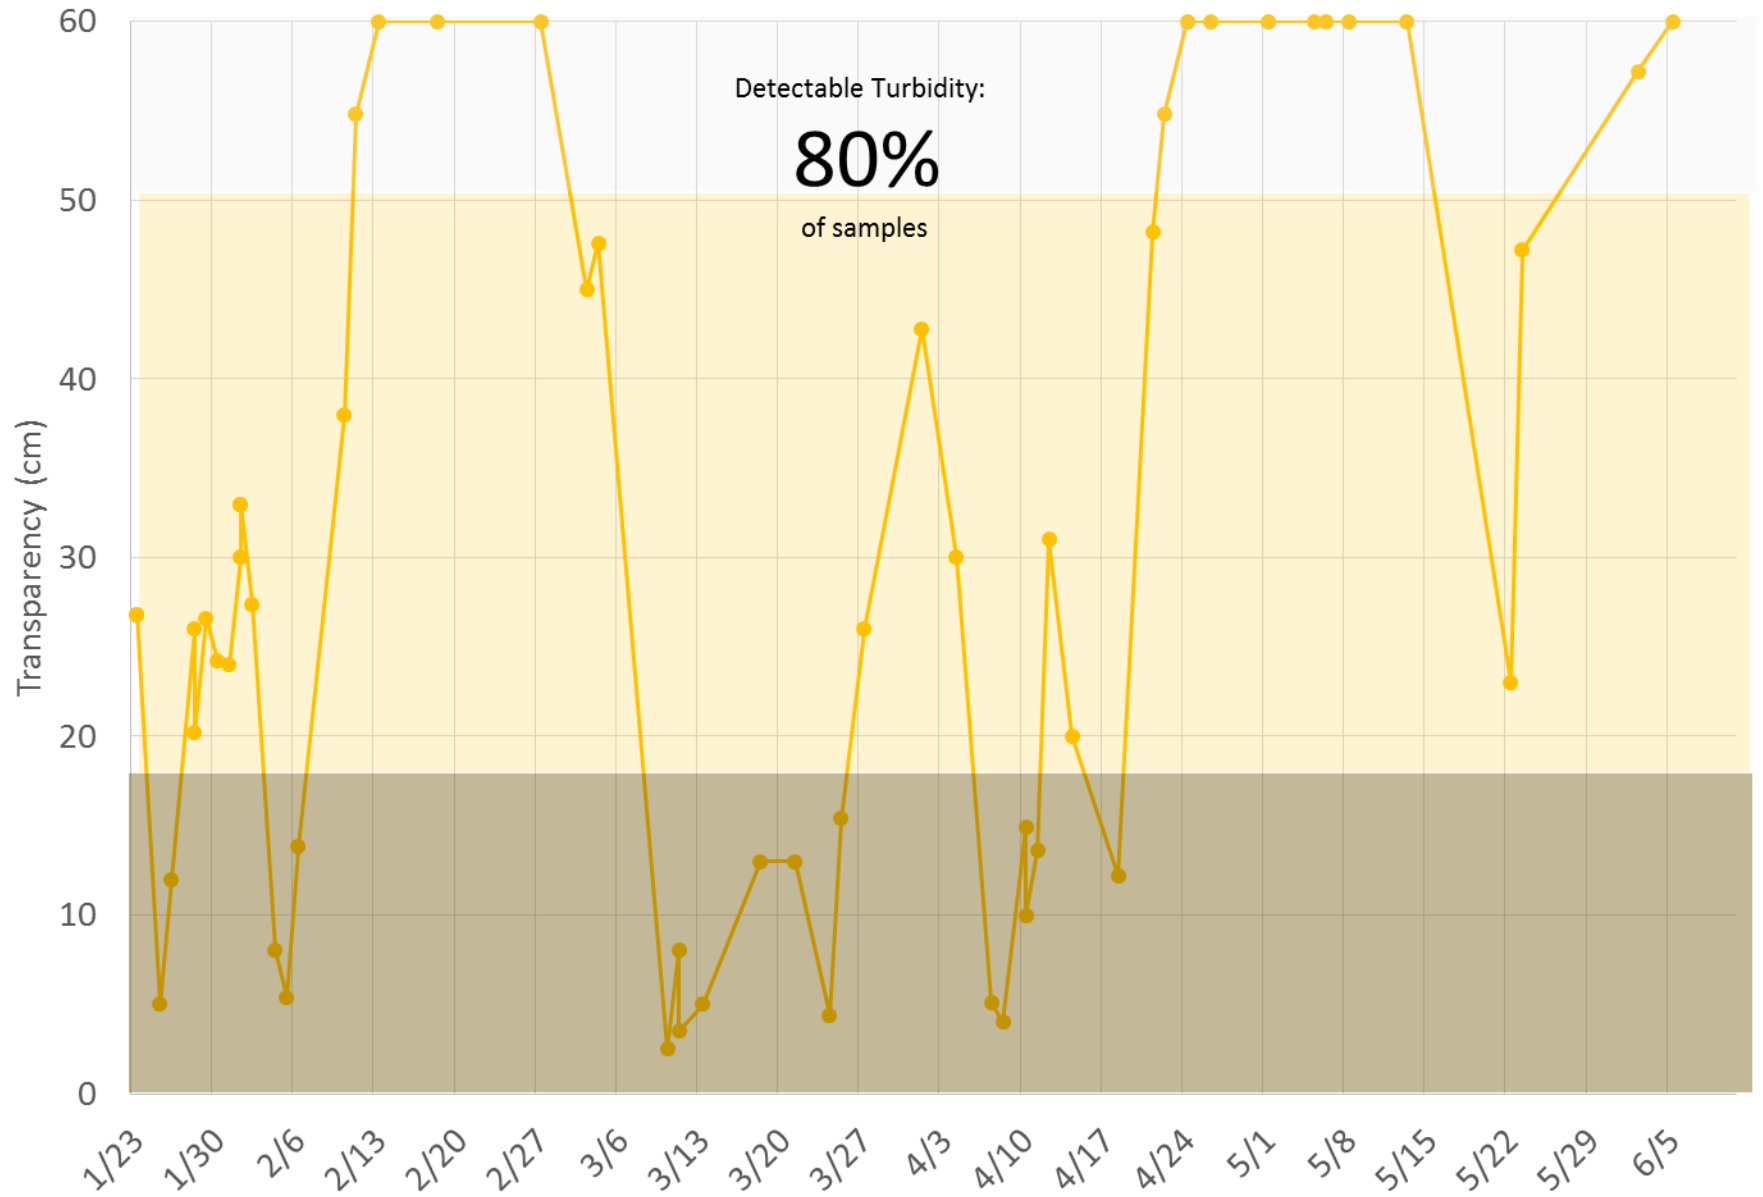
Spokane River-Riverside Cemetery

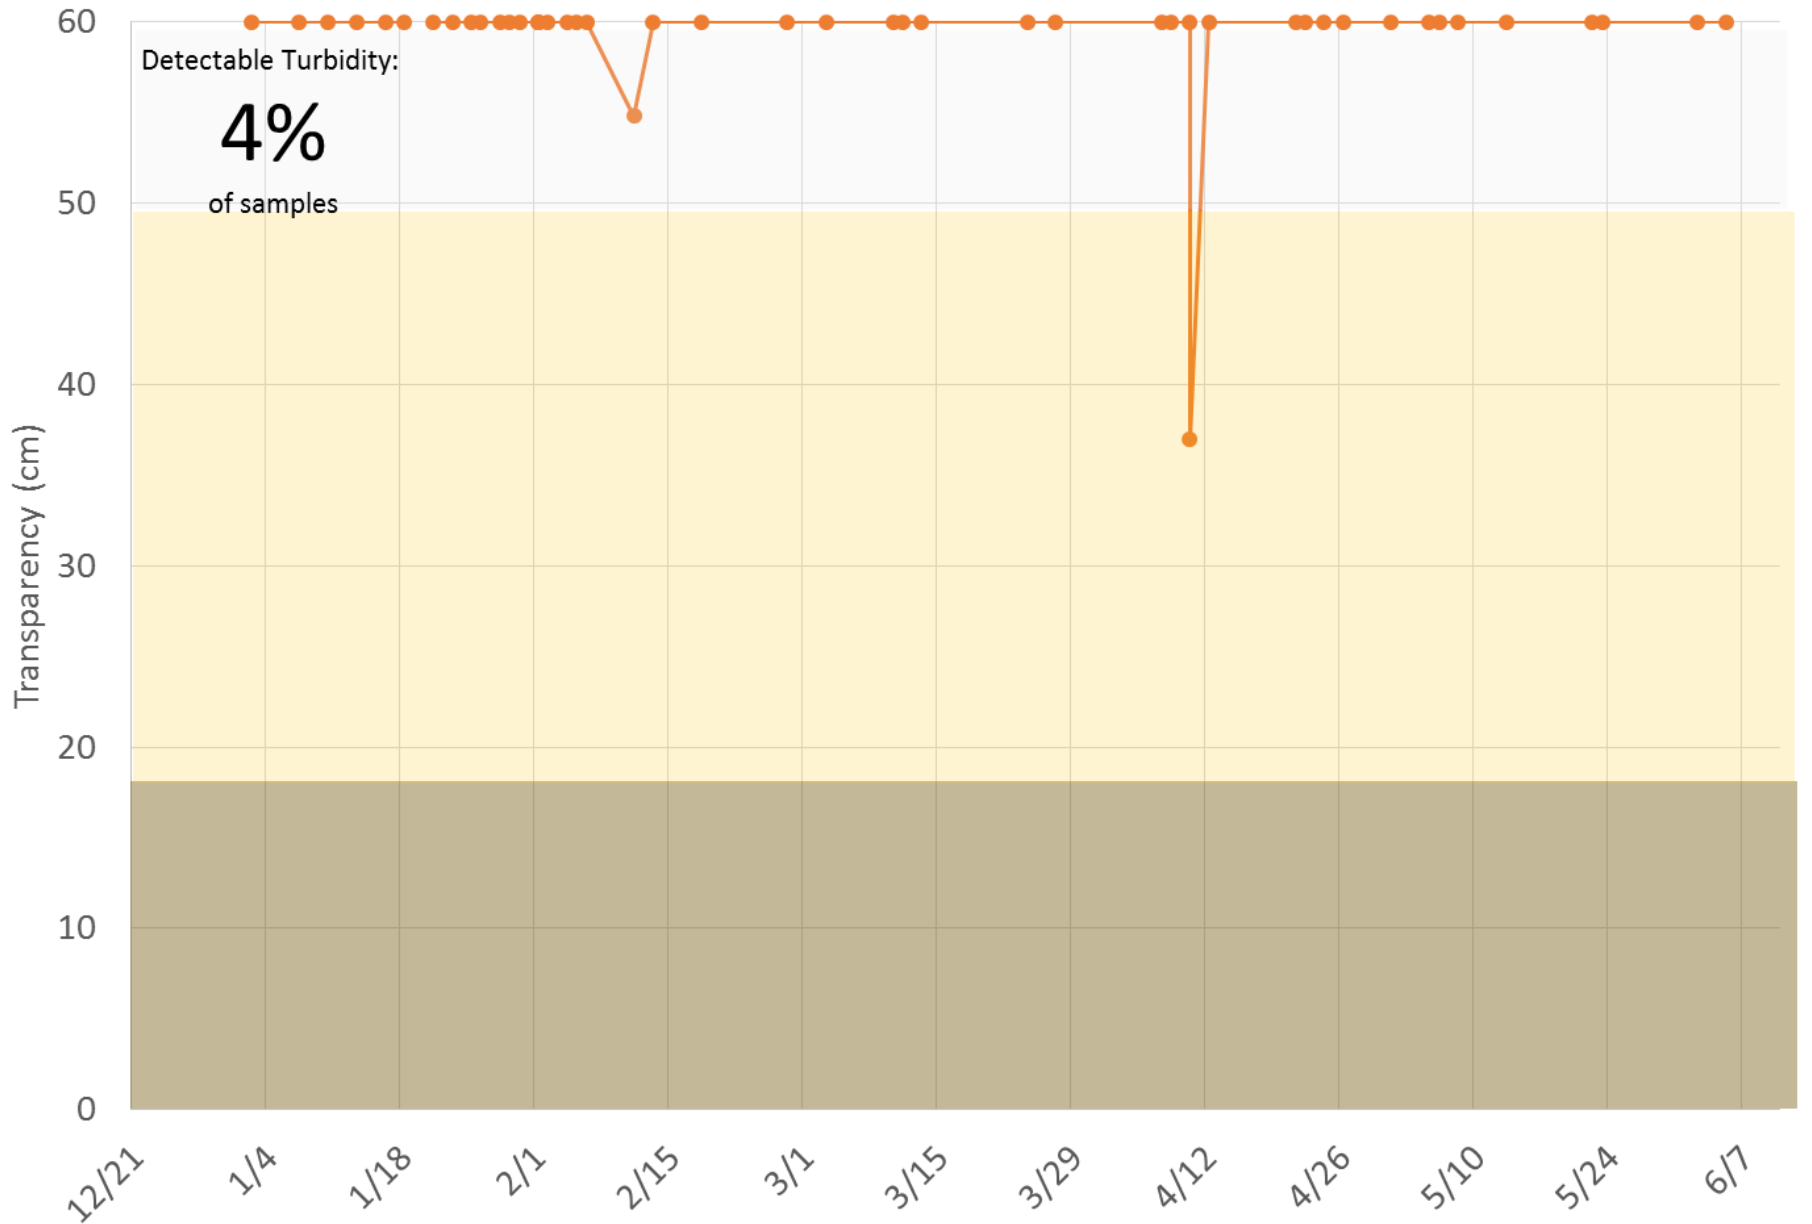
Spokane River - Sandifur Bridge (Upstream of Confluence)
